# VeLa Peakview Existing Conditions Survey

City of Colorado Springs Urban Renewal Authority

Economic & Planning Systems, Inc.

June 21, 2024

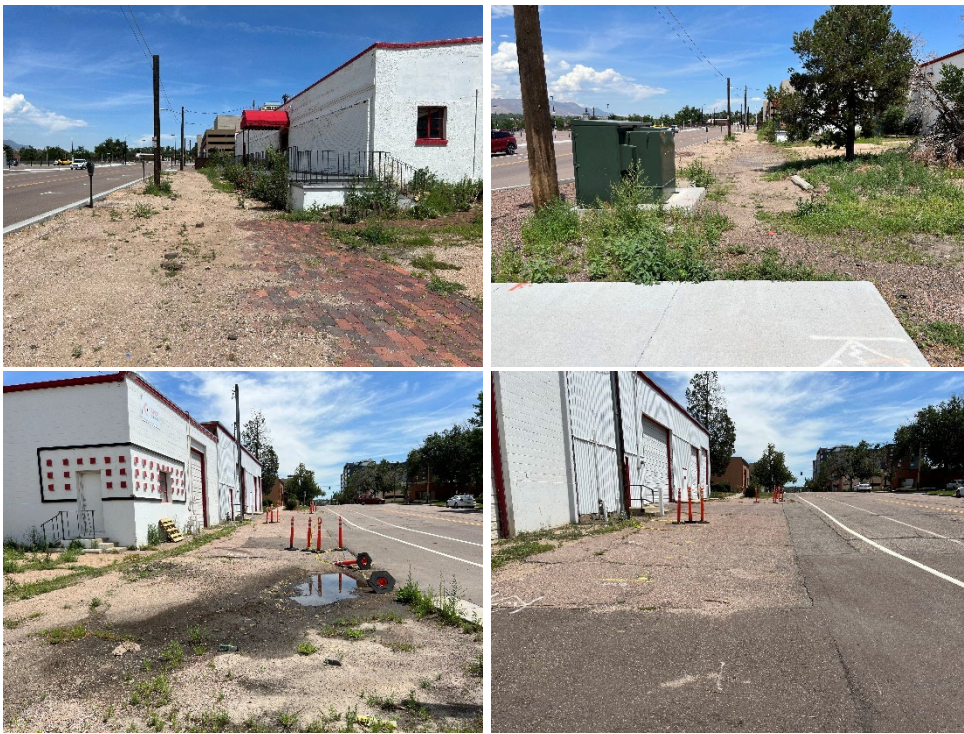
**Figure 3. Poor Provision of Street Improvements for Pedestrians**

Poor provisions of street improvements for pedestrians were observed in the form of lack of sidewalks along Sahwatch Street on parcel 1 and along Costilla Street on parcels 1 and 2, as shown in **Figure 3**. Along Sahwatch Street there is a defined curb but no sidewalk and along Costilla Street there is dirt and a large driveway for commercial vehicles. It is important to note at the corner of Sahwatch and Costilla Street pedestrian improvements were made with curb cuts and a small portion of sidewalk. These are extensions of the sidewalk improvements on the opposite sides of the streets and illustrates the disconnect the Study Area has within the existing pedestrian network.

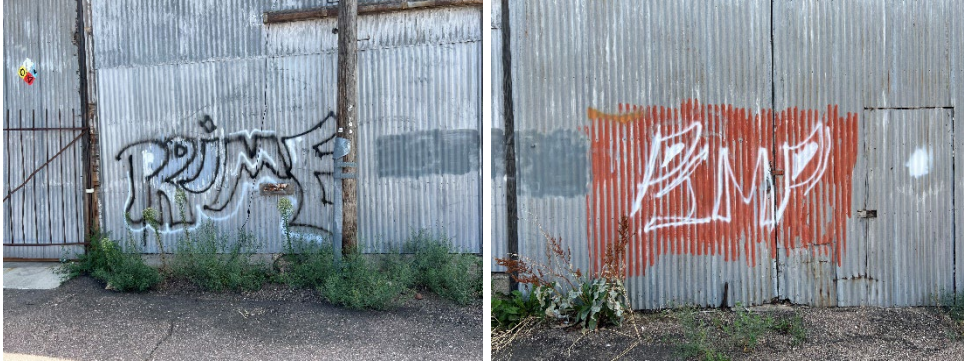
**Figure 6. Vandalism/Graffiti**

Throughout the Study Area unsafe and unsanitary conditions were documented, including vandalism/graffiti, excessive litter, and evidence of vagrants. Vandalism/graffiti was observed in alley on the backside of the building on parcel 2, shown in **Figure 6**.

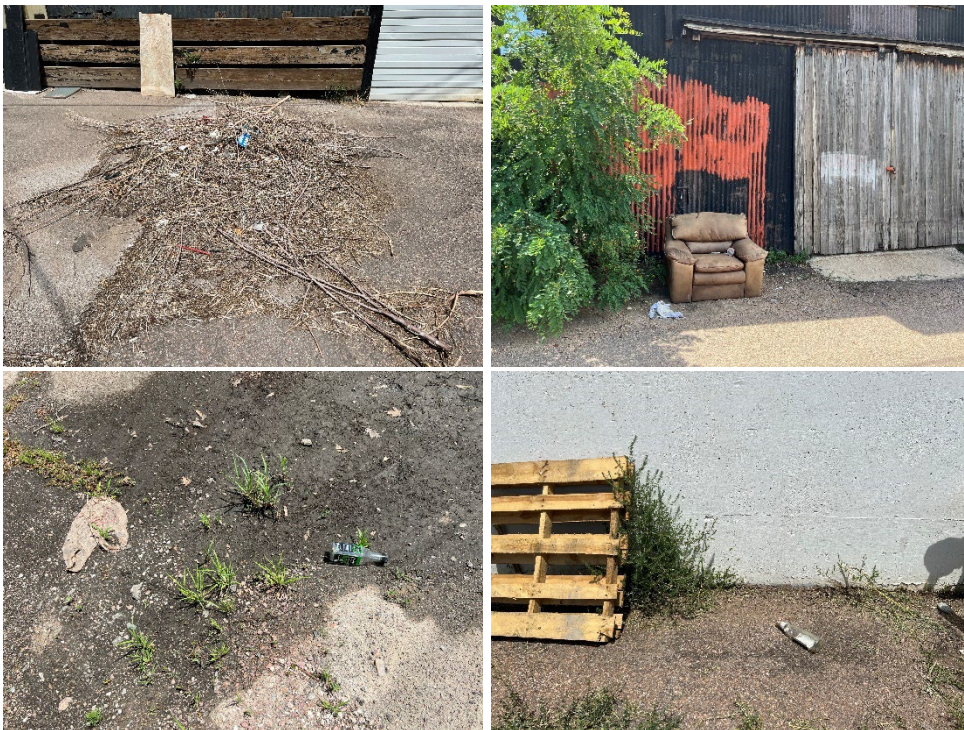
**Figure 7. Excessive Litter**

Excessive litter was observed and documented throughout the Study Area, shown in **Figure 7**.

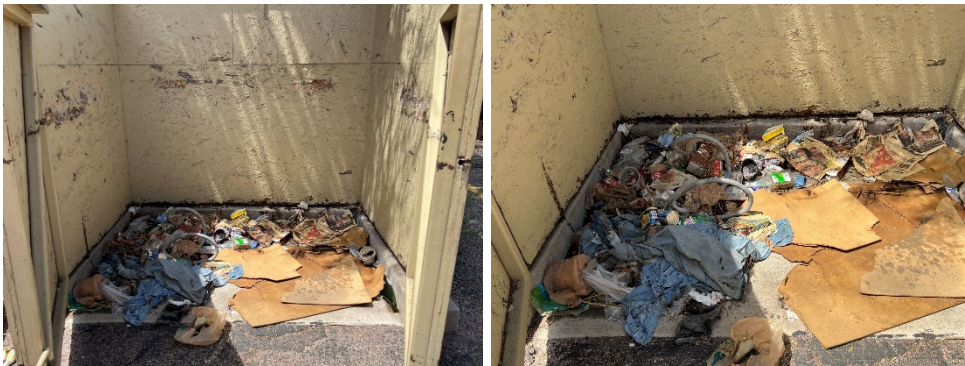
**Figure 8. Evidence of Vagrants**

Evidence of vagrant(s) was observed on parcel 4 in the gated area for the dumpster. The dumpster was removed and there was evidence that a person had been sleeping and hanging out there, shown in **Figure 8**.

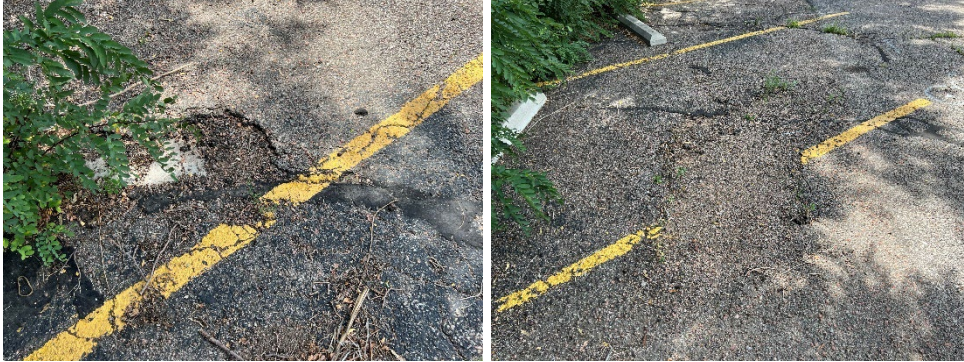
**Figure 10. Deteriorated On-Site Parking Surfaces**

Deterioration of site improvements were observed throughout the Study Area and overall the site shows signs of neglect. The small parking lot on parcel 4 showed signs of deterioration with missing sections of pavement and pot holes, shown in **Figure 10**.

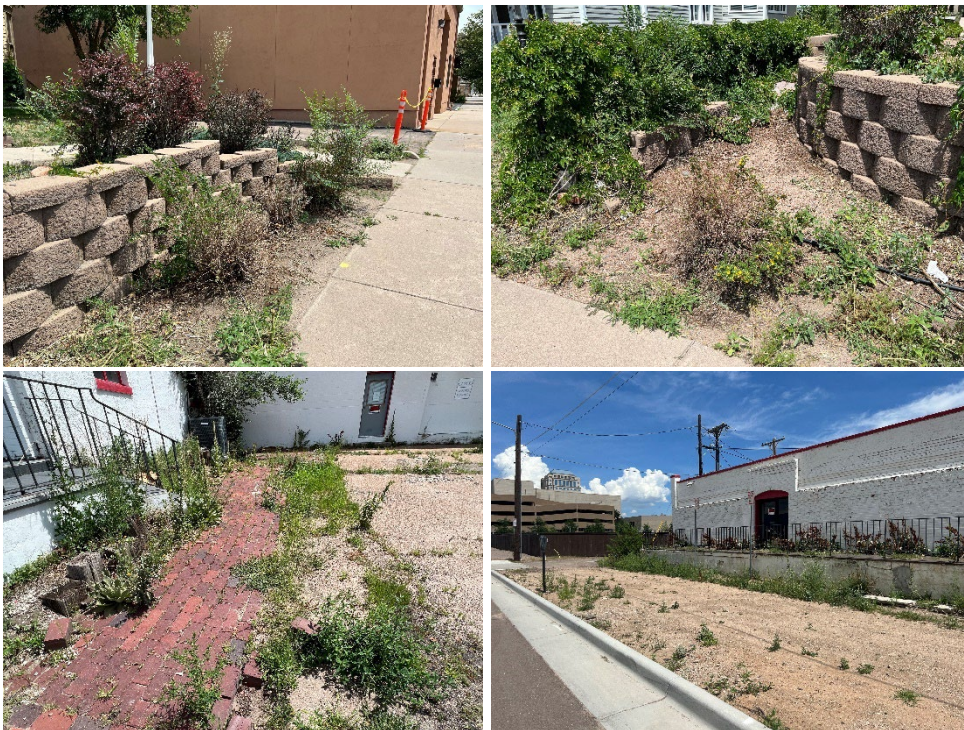
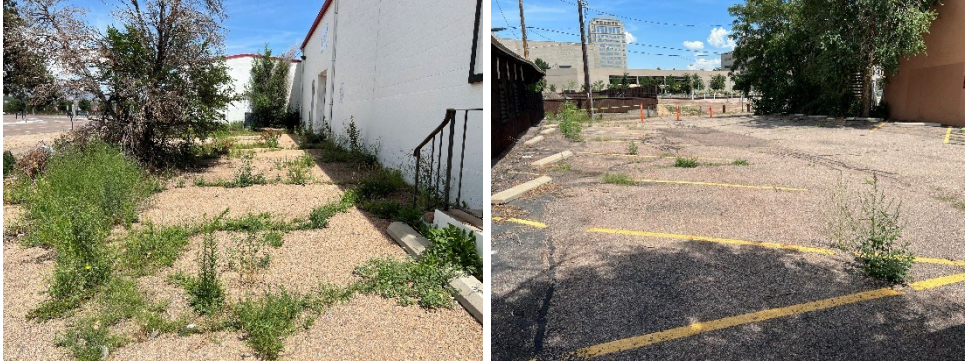
**Figure 11. Overgrown Vegetation**

Overgrown vegetation and poorly maintained landscaping was observed throughout the Study Area, shown in **Figure 11**.

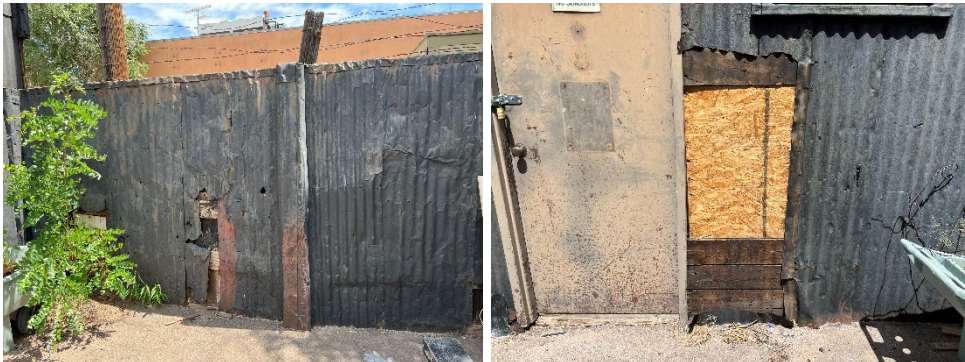
**Figure 12. Deteriorated Fences and Walls**

On parcel 3 a deteriorated portion of fence and exterior wall of the shed was observed, shown below in **Figure 12**.

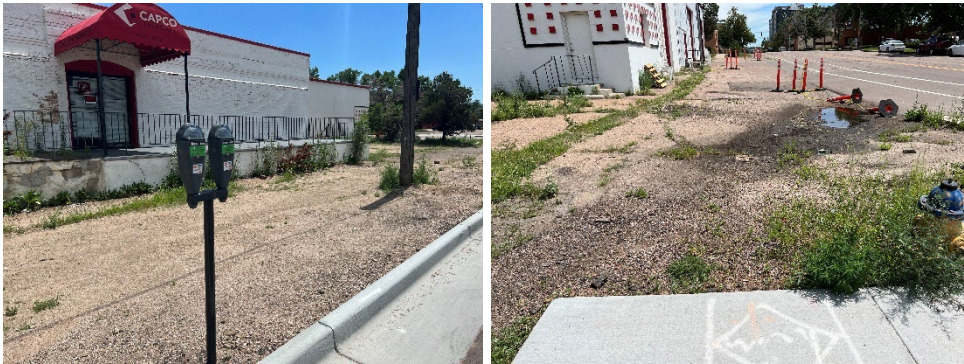
**Figure 13. Lack of Sidewalks and Curb**

Inadequate infrastructure was observed throughout the Study Area, predominately in the form of deteriorated pavement and lack of curbs and sidewalks. As previously mentioned, there is no sidewalk along Sahwatch Street and Costilla Street on parcels 1 and 2, shown in **Figure 13**.

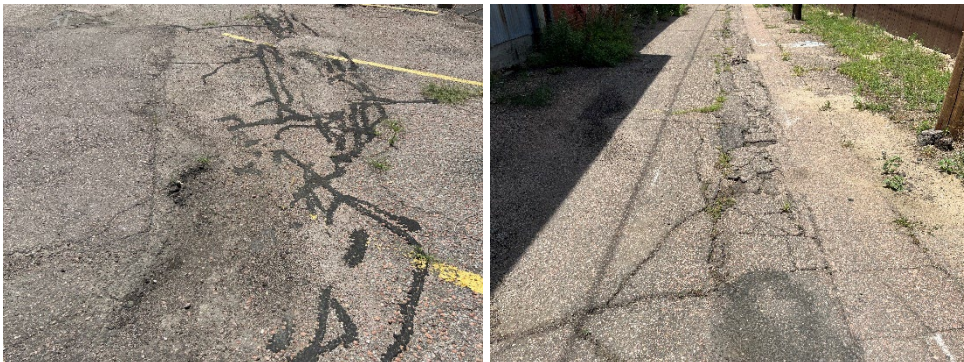
**Figure 14. Deteriorated Pavement**

In addition, the section along Costilla Street is also missing a curb. Deteriorated pavement was observed on the parking lot on parcel 4 and along the alley behind all the parcels, as shown in **Figure 14**.
