Final Report

Bristow-Lowell Existing Conditions Survey

City of Colorado Springs Urban Renewal Authority

June 17, 2024

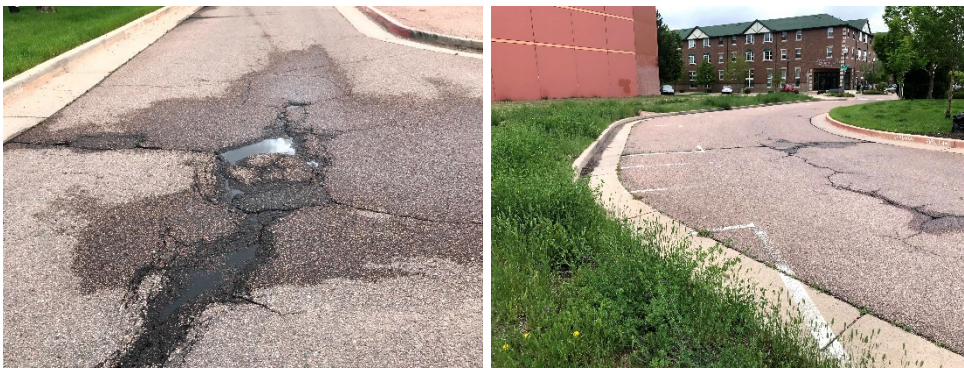
Figure 2. Poor Provision of Street Improvements

Along East Las Animas Street near parcels 1, 2, and 3 of the Study Area, poor provisions of the streets for vehicular traffic were observed in the form of large potholes and deteriorating pavement, shown in **Figure 2**. Throughout this portion of the Study Area, provisions of walkways for pedestrians were observed in the form of lack of sidewalks. In particular, parcel 3 has curb cuts but no paved sidewalk, shown in **Figure 3**. Additionally, there are no sidewalk or pedestrian improvements along parcels 4, 5, or 6 to connect to the existing pedestrian network on adjacent properties.

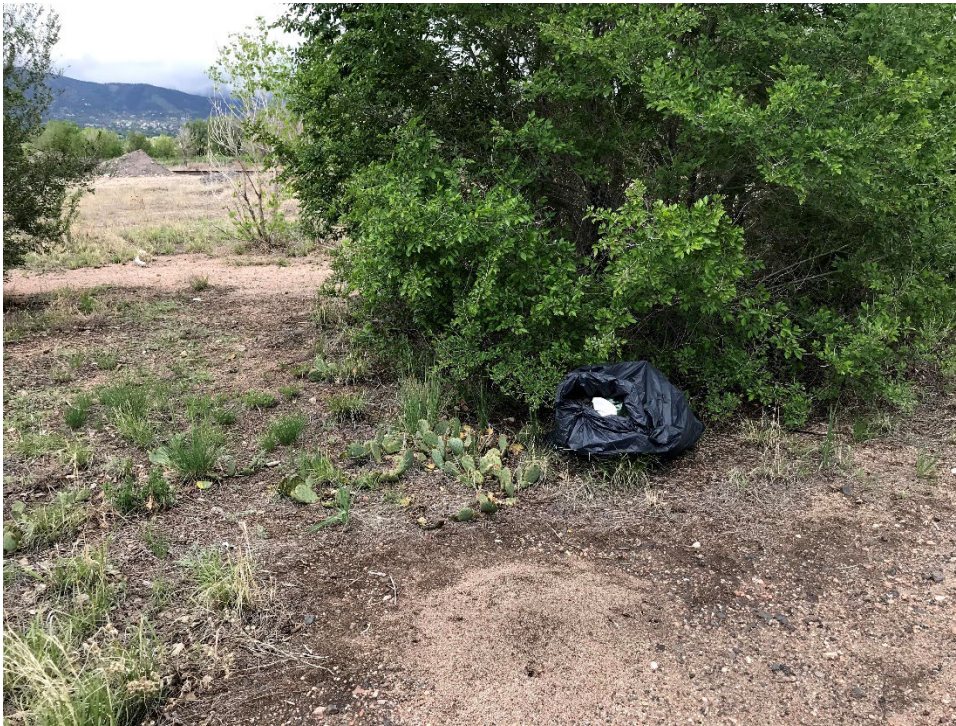
Figure 4. Illegal Dumping

Throughout the Study Area unsafe and unsanitary conditions were documented, including illegal dumping, litter, and evidence of vagrants. Illegal dumping was observed southeast of the railroad tracks, shown in **Figure 4**. Excessive litter was observed and documented throughout the properties and was especially apparent along East Fountain Boulevard, shown in **Figure 5**. There was evidence of vagrants on the property with a makeshift sleeping area shown in **Figure 6**. Additionally, using Google Earth imagery there were excessive homeless encampments throughout parcels 6 and 7, shown in **Figure 7**.

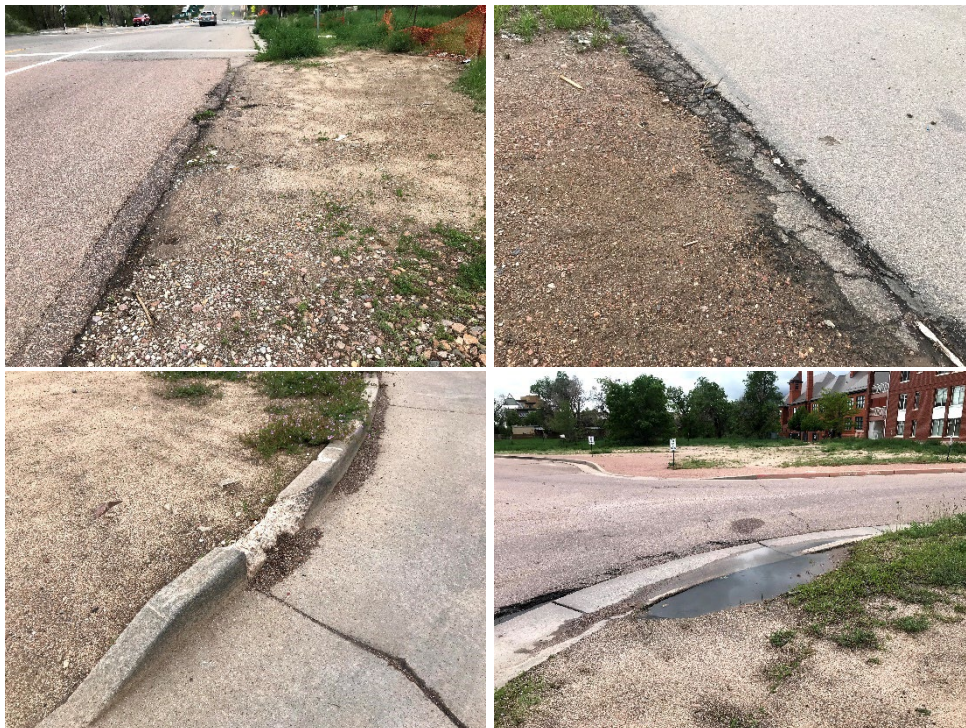
Figure 8. Deteriorated Curbs

There are very minimal site improvements on the properties. Of the improvements in place, deterioration of curbs was most apparent. This was observed for the parcels along East Fountain Boulevard as well as parcels along East Las Animas Street in the Study Area, shown in **Figure 8**. Overall, there was evidence that the properties have been neglected with little maintenance.

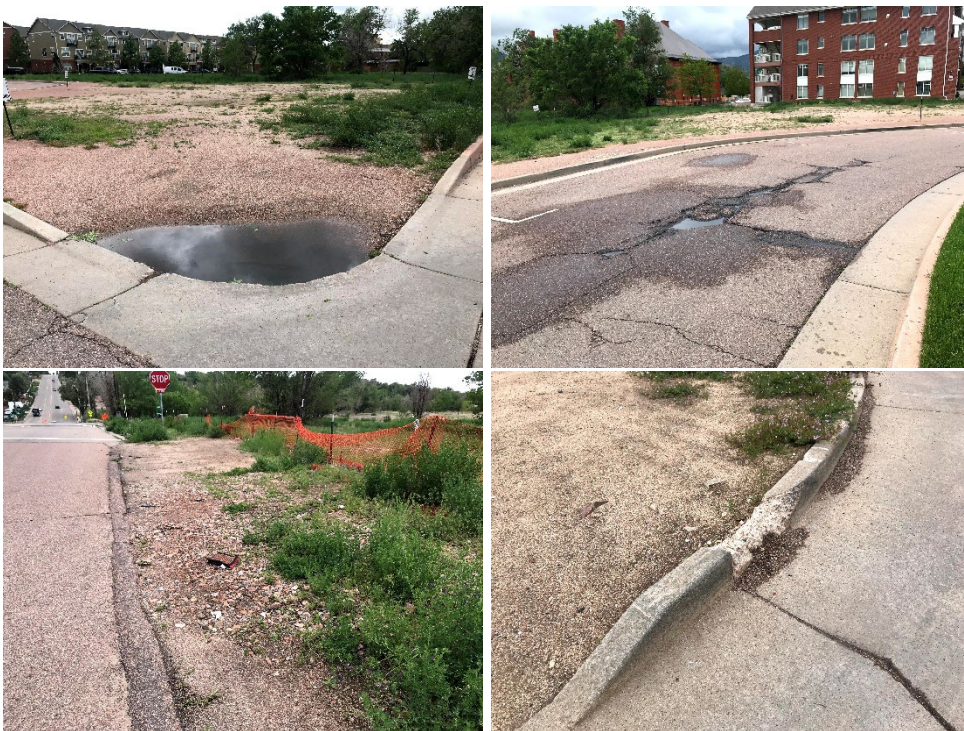
Figure 9. Deteriorated Pavement and Curbs and Missing Sidewalks

Inadequate infrastructure was observed throughout the Study Area, predominately in the form of deteriorated pavement, deteriorated or missing curbs, and missing sidewalks, shown in **Figure 9**. Additionally, unusual topography was observed in parcels 6 and 7 in the form of steep slopes, shown in **Figure 10**.

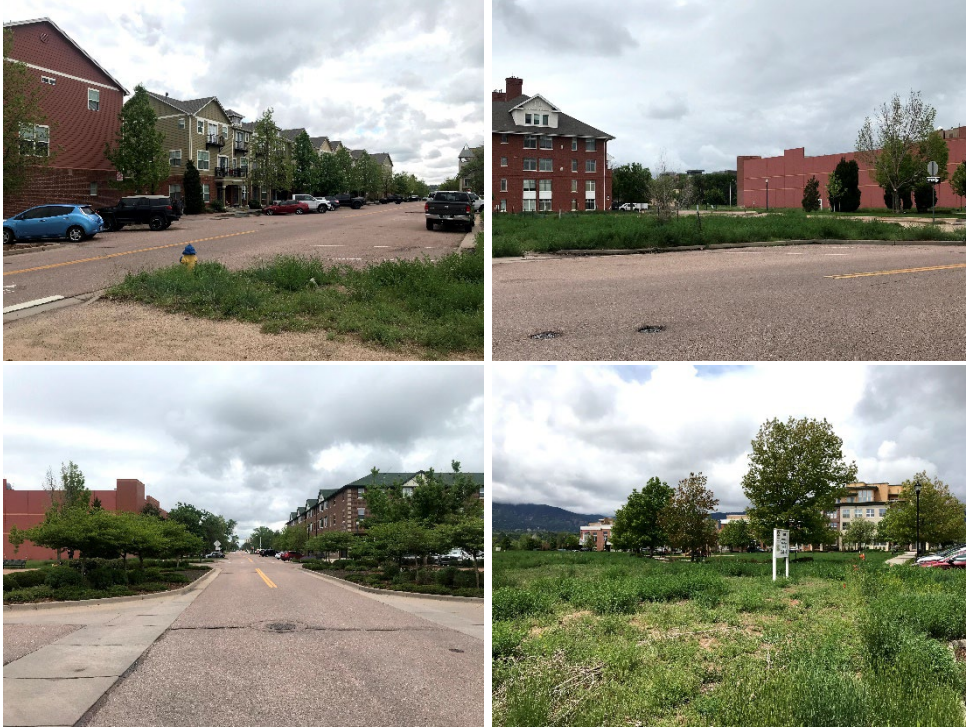
Figure 11. Vacant Property in Generally Urbanized Area

The entire 7.26-acre Study Area is vacant with no building improvements. The properties are surrounded by development, shown in **Figure 11**, with townhomes and a park along East Fountain Road and South Weber Street, Colorado Springs Police Department north of parcels 1 and 2, and various commercial properties and Shooks Run Trail east of parcel 7. Additionally, railroad tracks run through the Study Area between parcels 5, 6, and 7. There are multiple planned and proposed infill developments on parcels near the Study Area that will be market rate housing. This area southeast of downtown is very urban and the Study Area are one of the few remaining properties undeveloped.
