## Draft Report

# O'Neil Existing Conditions Survey

City of Colorado Springs Urban Renewal Authority

August 19, 2022

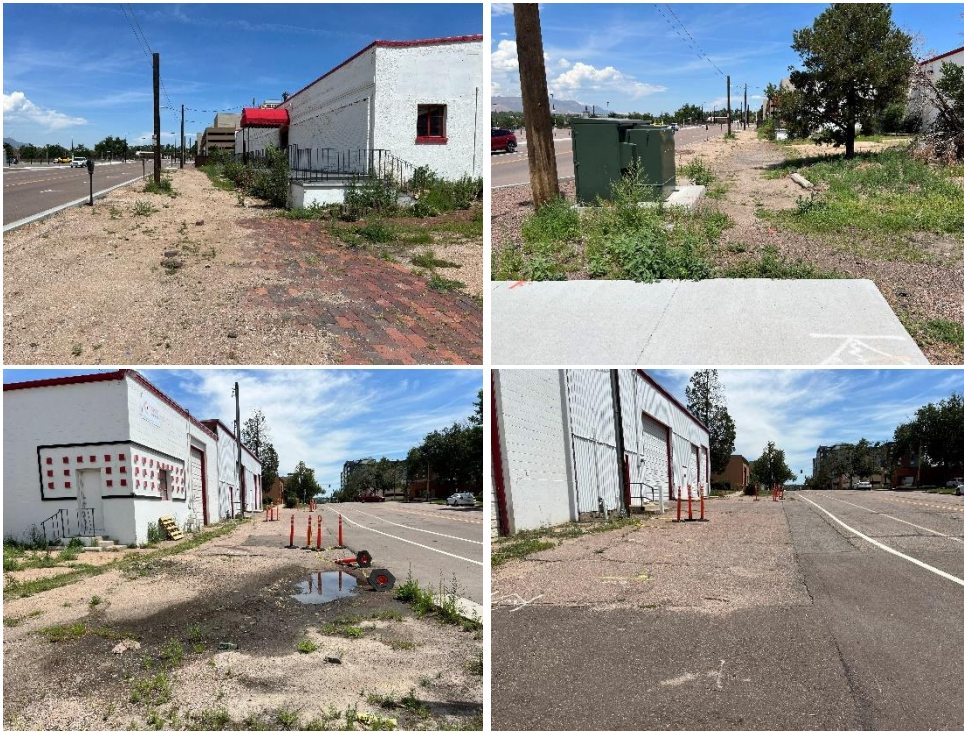
**Figure 3. Poor Provision of Street Improvements for Pedestrians**

Poor provisions of street improvements for pedestrians were observed in the form of lack of sidewalks along Sahwatch Street on parcel 1 and along Costilla Street on parcels 1 and 2, as shown in **Figure 3**. Along Sahwatch Street there is a defined curb but no sidewalk and along Costilla Street there is dirt and a large driveway for commercial vehicles. It is important to note at the corner of Sahwatch and Costilla Street pedestrian improvements were made with curb cuts and a small portion of sidewalk. These are extensions of the sidewalk improvements on the opposite sides of the streets and illustrates the disconnect the Study Area has within the existing pedestrian network.

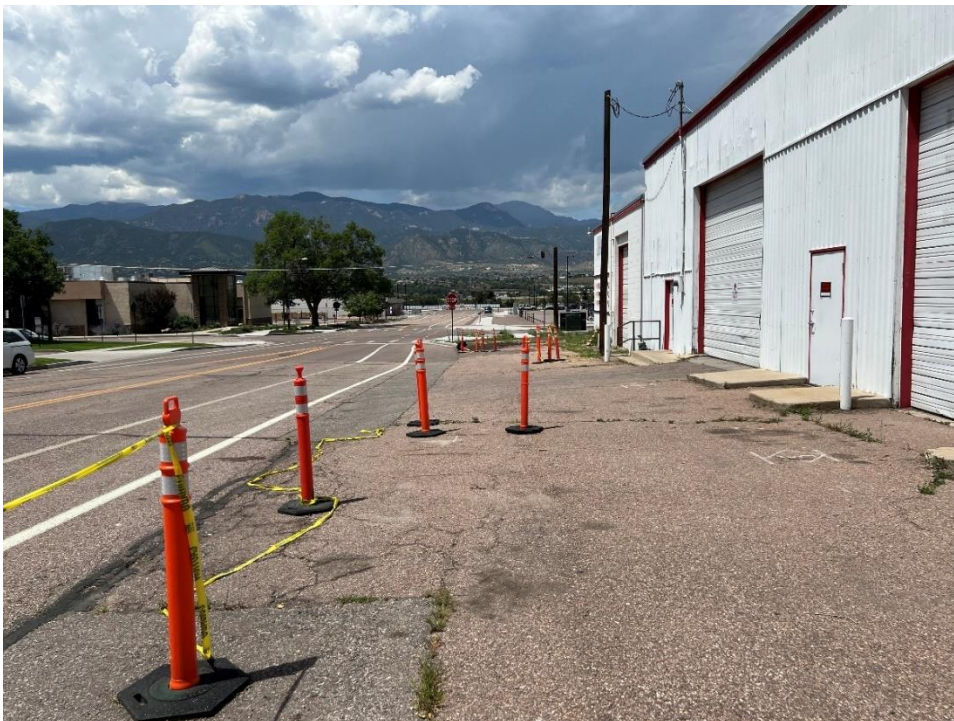
**Figure 5. Excessive Curb Cuts Along Commercial Blocks**

There is an excessive driveway along Costilla Street for the existing warehouse/storage facilities on parcels 1 and 2, shown in **Figure 5**. The drive covers approximately a third of the block and does not include curb cuts or a sidewalk.

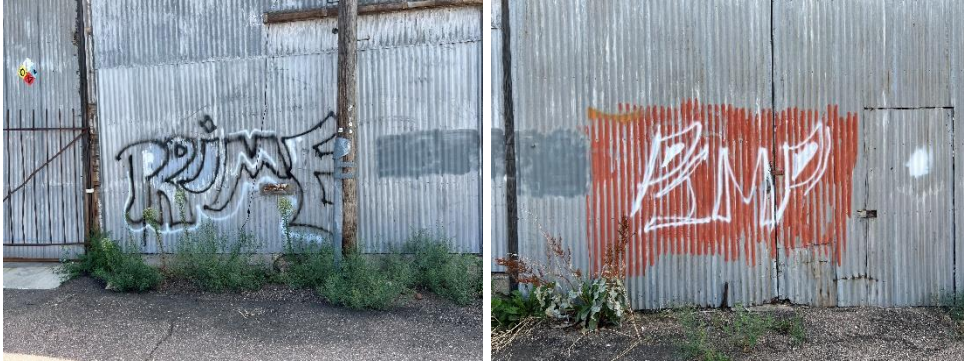
**Figure 6. Vandalism/Graffiti**

Throughout the Study Area unsafe and unsanitary conditions were documented, including vandalism/graffiti, excessive litter, and evidence of vagrants. Vandalism/graffiti was observed in alley on the backside of the building on parcel 2, shown in **Figure 6**.

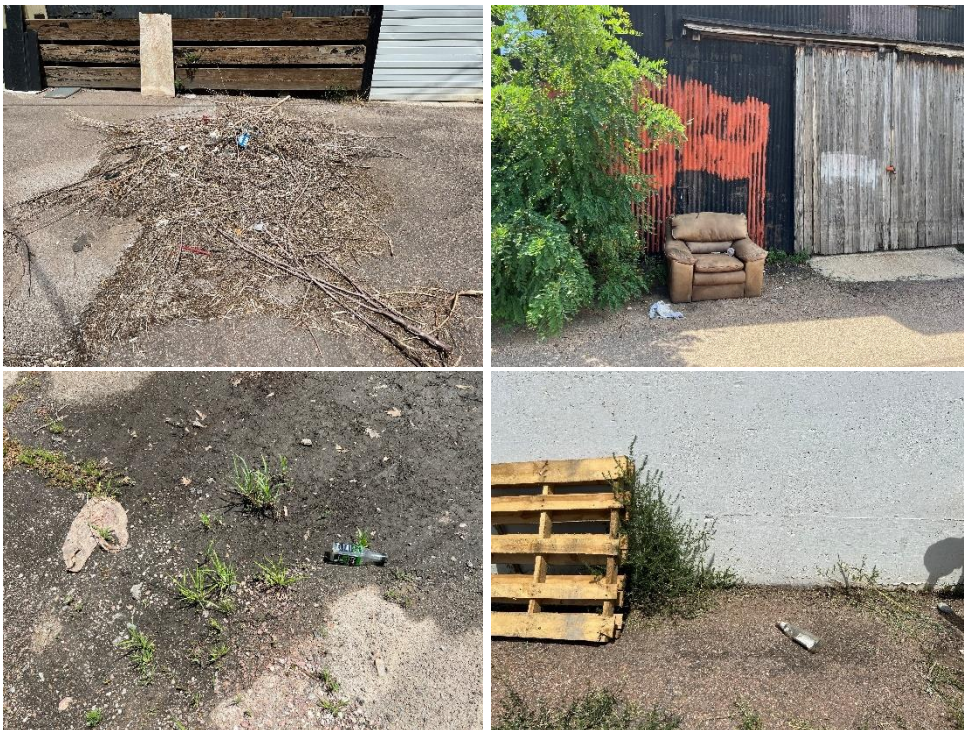
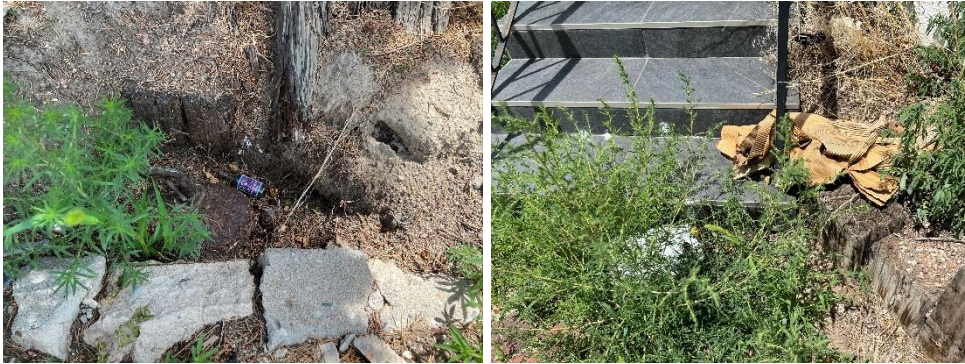
**Figure 7. Excessive Litter**

Excessive litter was observed and documented throughout the Study Area, shown in **Figure 7**.

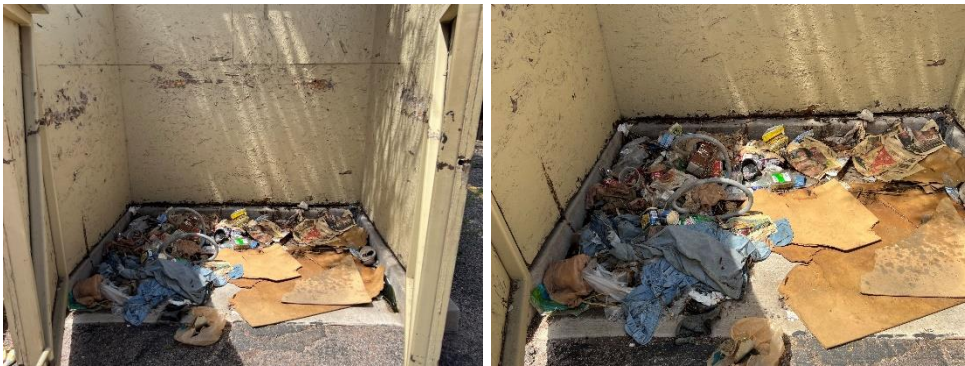
**Figure 8. Evidence of Vagrants**

Evidence of vagrant(s) was observed on parcel 4 in the gated area for the dumpster. The dumpster was removed and there was evidence that a person had been sleeping and hanging out there, shown in **Figure 8**.

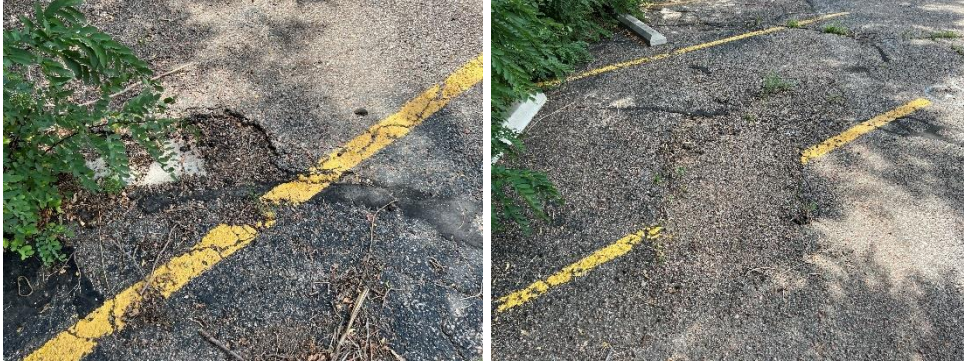
**Figure 10. Deteriorated On-Site Parking Surfaces**

Deterioration of site improvements were observed throughout the Study Area and overall the site shows signs of neglect. The small parking lot on parcel 4 showed signs of deterioration with missing sections of pavement and pot holes, shown in **Figure 10**.

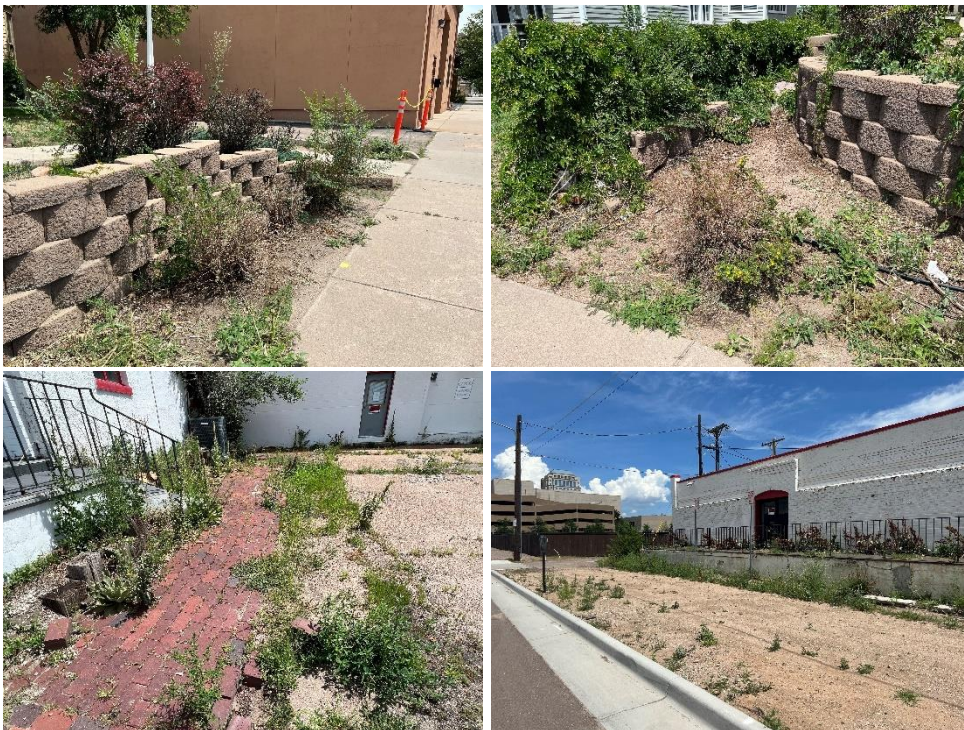
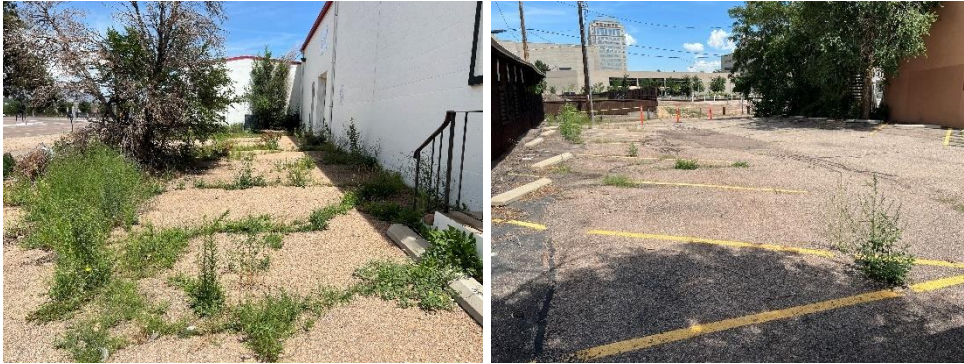
**Figure 11. Overgrown Vegetation**

Overgrown vegetation and poorly maintained landscaping was observed throughout the Study Area, shown in **Figure 11**.

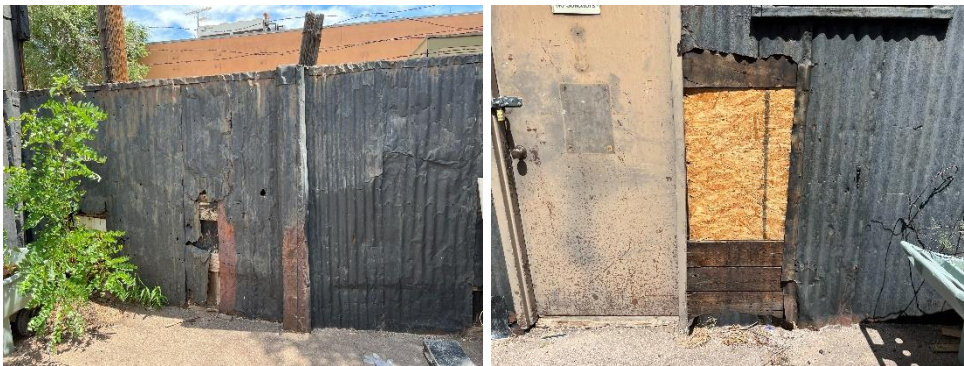
**Figure 12. Deteriorated Fences and Walls**

On parcel 3 a deteriorated portion of fence and exterior wall of the shed was observed, shown below in **Figure 12**.

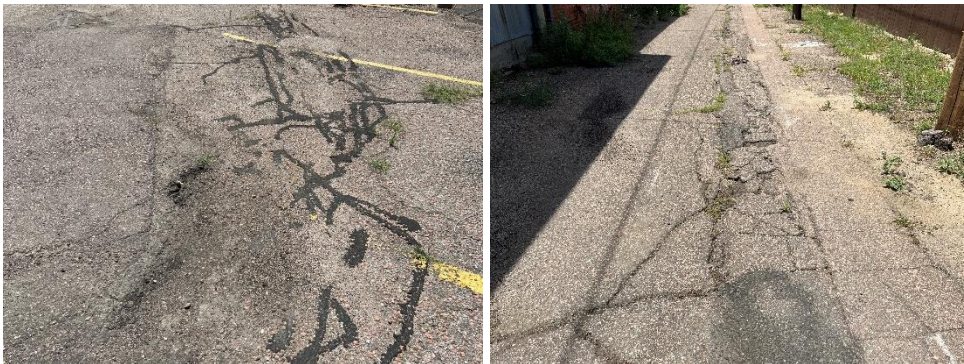
**Figure 14. Deteriorated Pavement**

In addition, the section along Costilla Street is also missing a curb. Deteriorated pavement was observed on the parking lot on parcel 4 and along the alley behind all the parcels, as shown in **Figure 14**.

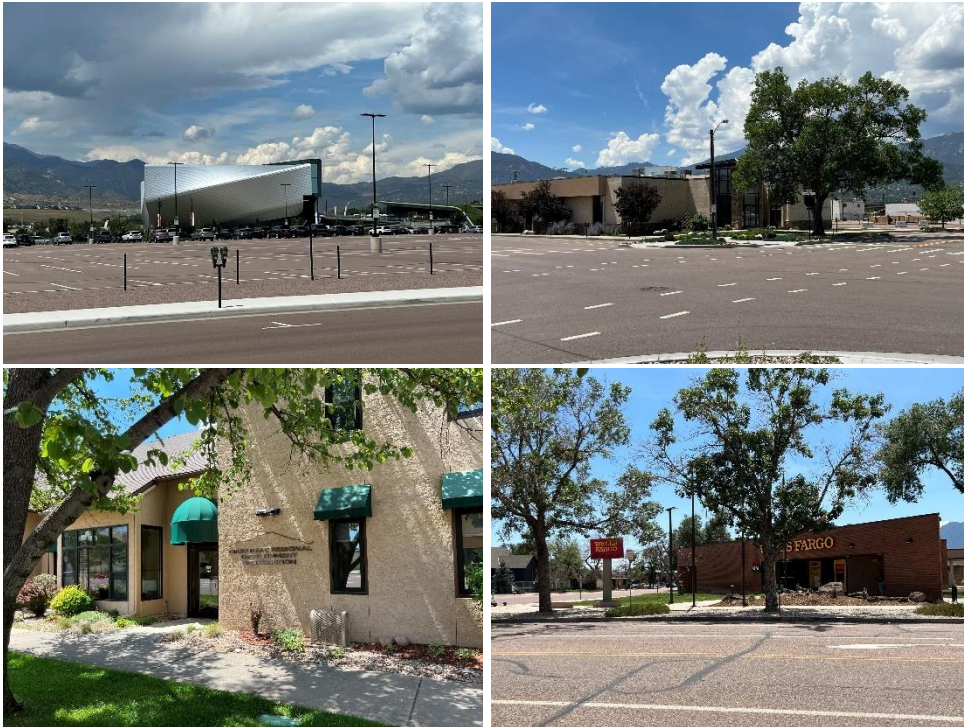
**Figure 15. Underdeveloped Parcels in an Urbanized Area**

The Study Area is comprised of parcels that are underdeveloped and underutilized in the urban location. The surrounding context of the Study Area is largely developed with commercial uses, shown in **Figure 15**, with the U.S. Olympic and Paralympic Muesum to the west, Colorado Springs Conservatory and Wells Fargo Bank to the south, Pikes Peak Regional Development Corporation to the east, and government buildings on the block to the north. The Study Area is in Downtown Colorado Springs and currently underutilized with older industrial uses and single family residences, all of which are currently vacant.
